P.A. RECONS - ROCKLAND COUNTY  
PROJECT MANAGER - DAVE GRUPP  
TDD#'S 02-8604-09, 10, 21, 22, 23  
FIELD NOTEBOOK 2080  
MAY 6, 1986

RAMARO LAND COMPANY

West NYACK Site.

Midland Processing 02-8604-22 5/7/86

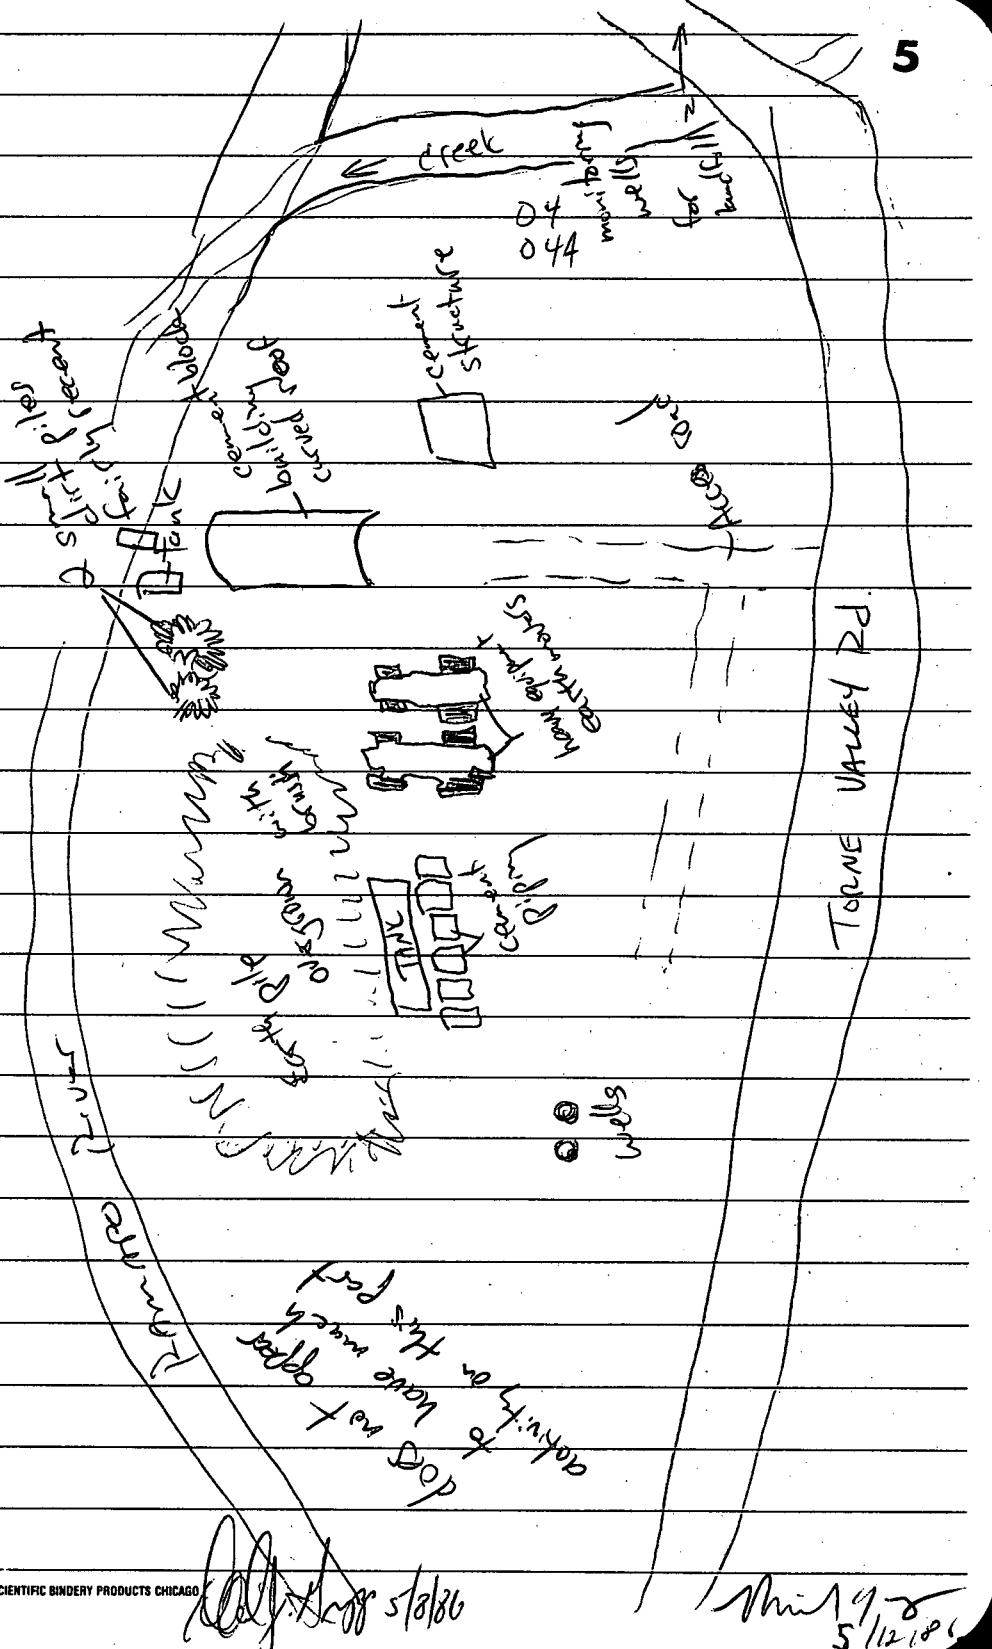
on left side as you are driving north. Ramaro  
Landfill is located just north of the site on  
right side of the road. The site is mounded  
in several areas and overgrown with brush  
and grasses. Primary succession. Several pieces of  
heavy earth moving equipment are on site  
along with other debris including large cement  
piping & wood material.

1000 - No evidence of drums on site as noted  
in background file. Several discarded metallic  
tanks are on site. Most recent activity appears  
to be near the on site cement block building.  
No activity was observed while near the site.  
Several monitoring wells are on site. Two  
near north border one near the middle  
and two additional ones towards the south.  
These are for monitoring the landfill  
wells are not secured.

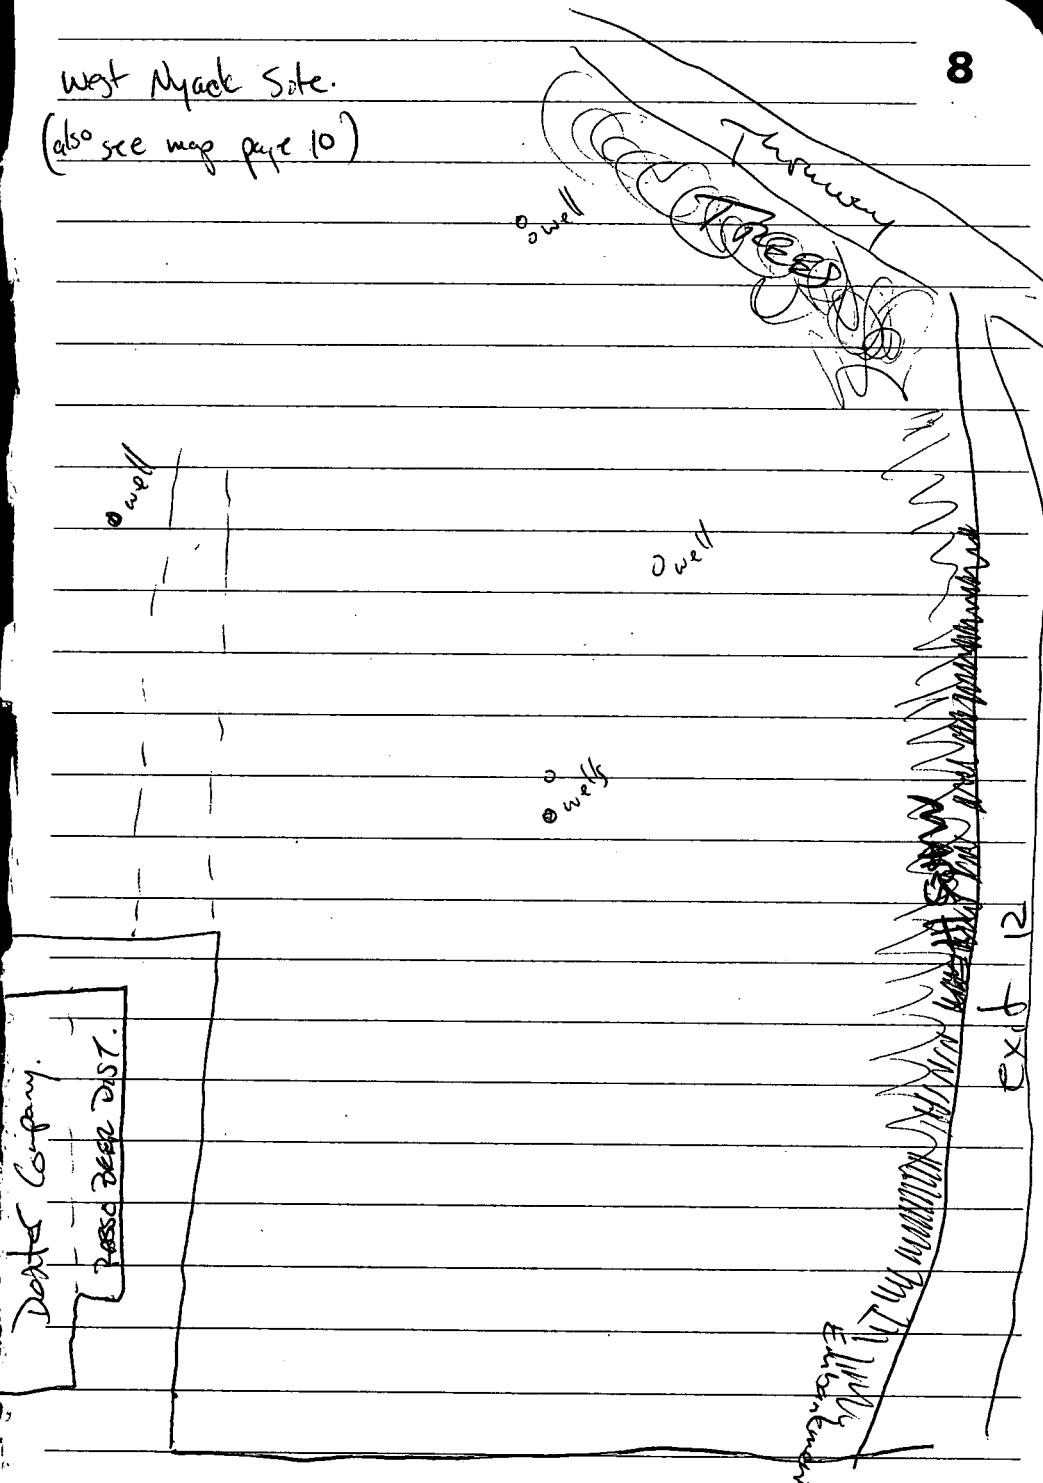
West Nyack Sote.  
(also see map page 10)

Access can be gained off of route 59 - Dexter Ave. is the name of the access Road. Area here is overgrown with trees about 10-15 years in age also very marshy. No evidence of fill in this area. One well cluster is noted as well as a drum storage area (snowfence) containing yellow waste drums and crushed discarded ~~discarded~~ (D) discarded drums.

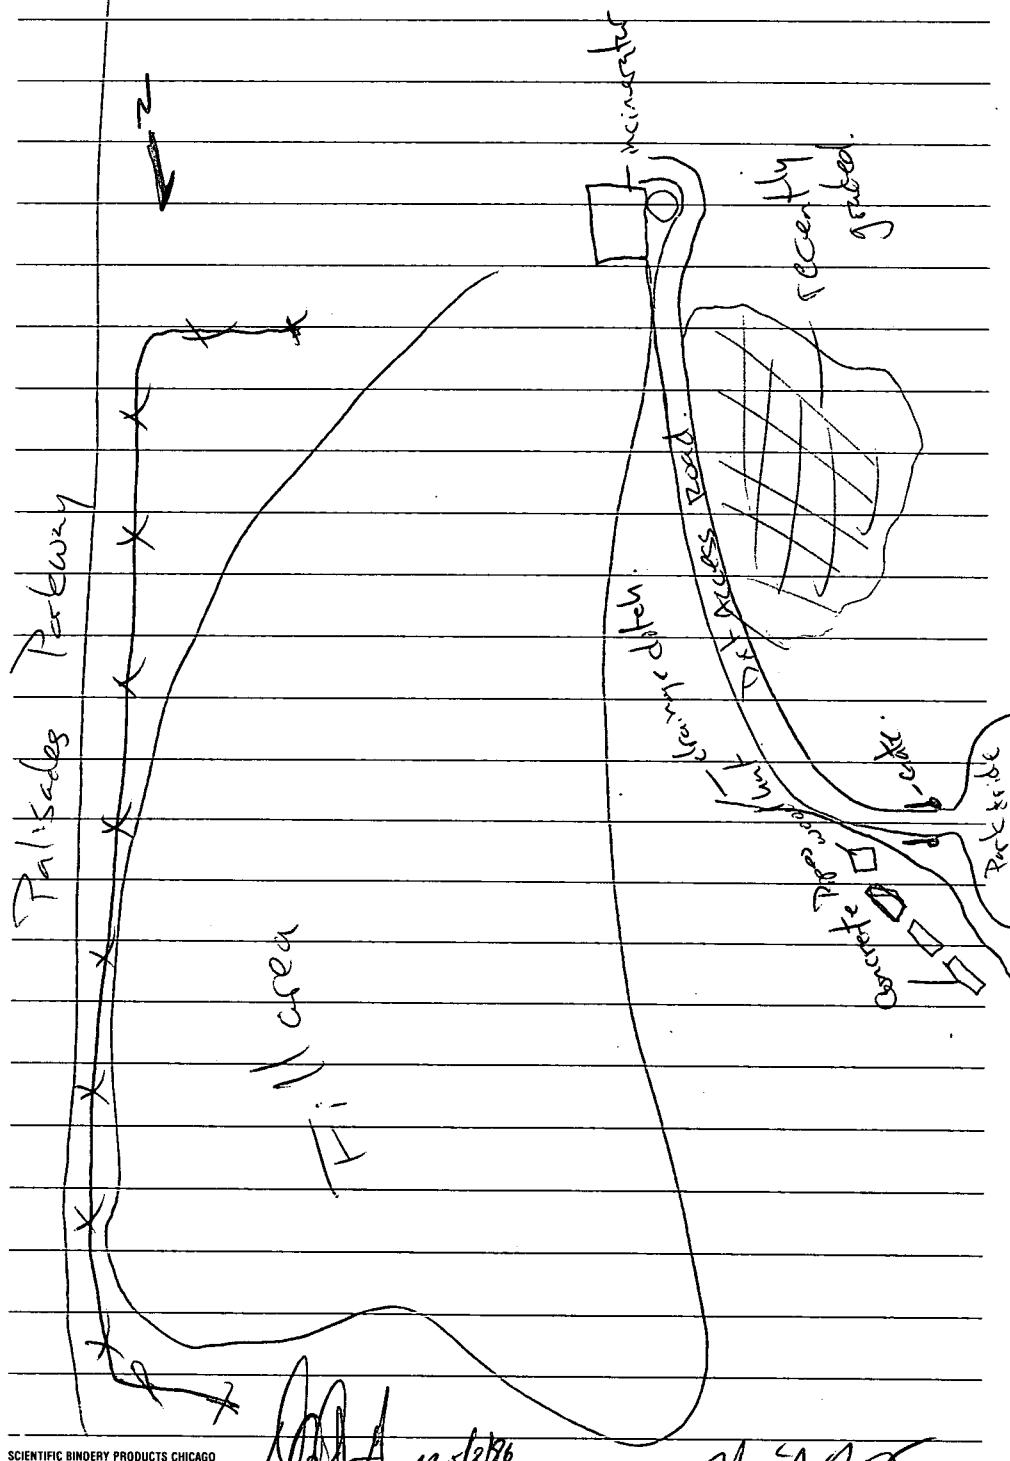
## RAMAPO Incinerator

Fill area is very mounded, and does not appear to have been graded at any time. Vegetation on the fill ~~is~~ consists of grasses. Scattered refuse, appliances and concrete sewer piping is visible. Small intermittent drainage stream runs from fill area along access road. Access road runs in a southerly direction towards the incinerator. The area directly west of access road has been graded recently. Landfill activity took place north of incinerator.

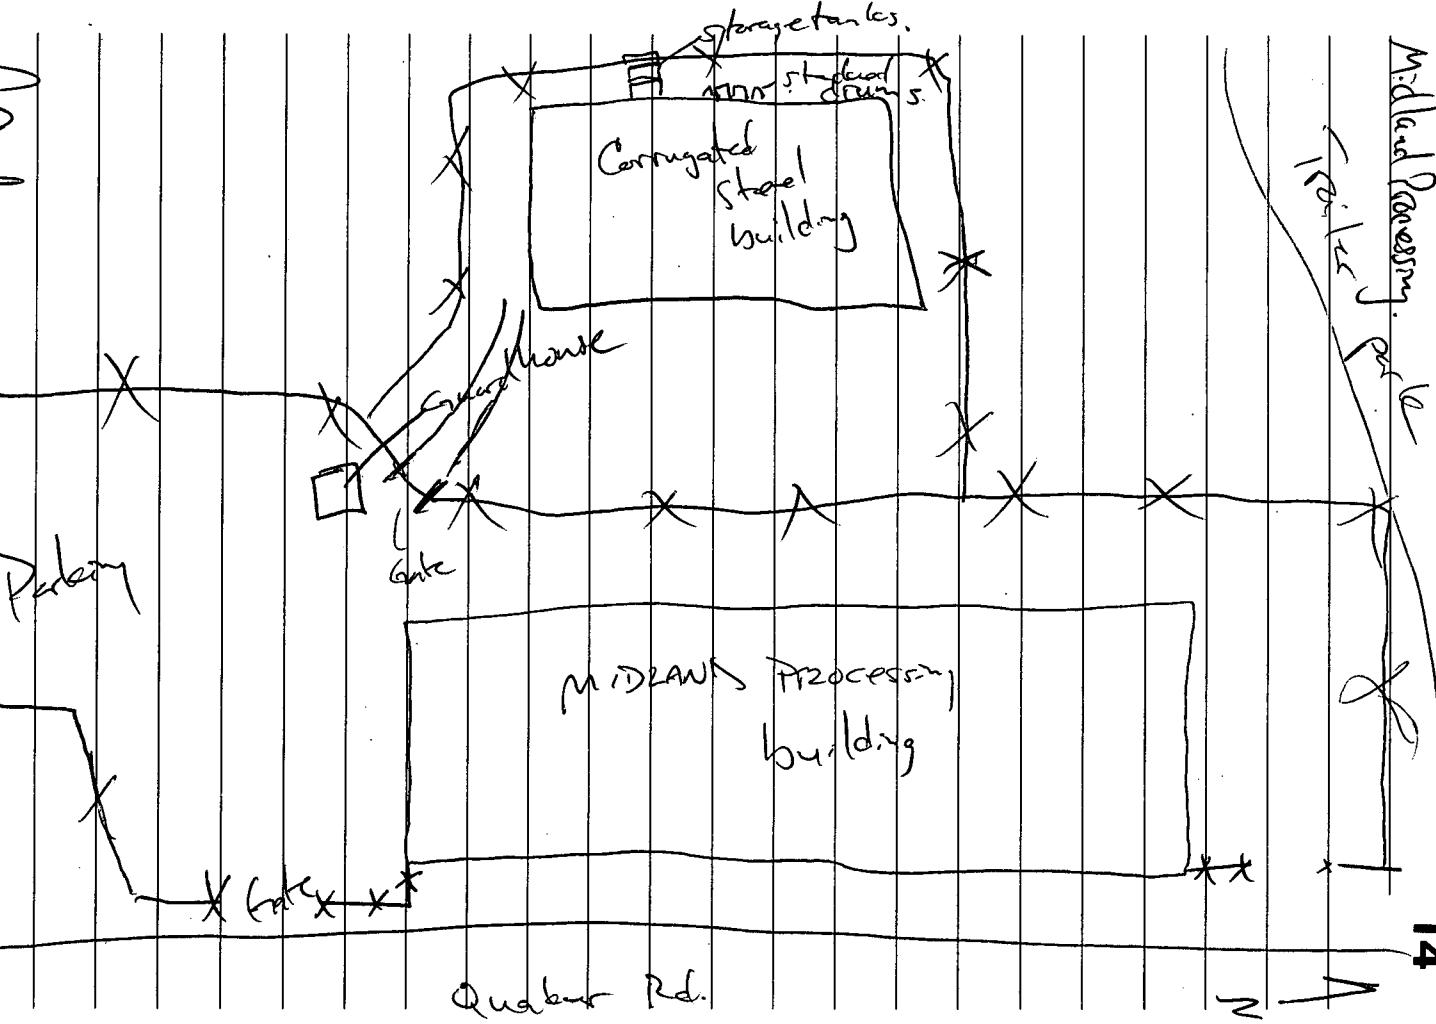
Parkway adjacent to Rt. 202. Site consists of a building which appears to be mostly vacant and an asphalt paved parking lot. The building takes up most of the site. Entire property may be ~~so~~ ① 5 acres in size. Site is on a hill overlooking a trailer park. The site is fenced but gates are open with no security. Some activity most likely warehouse of some sort is taking place. Three cars were noted on site along with a truck in the loading dock area. Unless illegal dumping has taken place in-side the building, there does not appear to be any illegal or hazardous waste activities on the outside.

of the site down a hill to an additional building made of corrugated steel. There appears to be activity in this area but it is difficult to see what is going on down there, there appears to be a couple of above ground storage tanks along the west side of the building along with some drums. The building is fenced and the only access to it appears to be through the property at the top of the road (Quaker Rd.).
